MUNICIPALITY OF AMORGOS

Management
for ecosystem recovery
in Amorgos Island

Location: Aspro Vouno, Chora area

May 2014

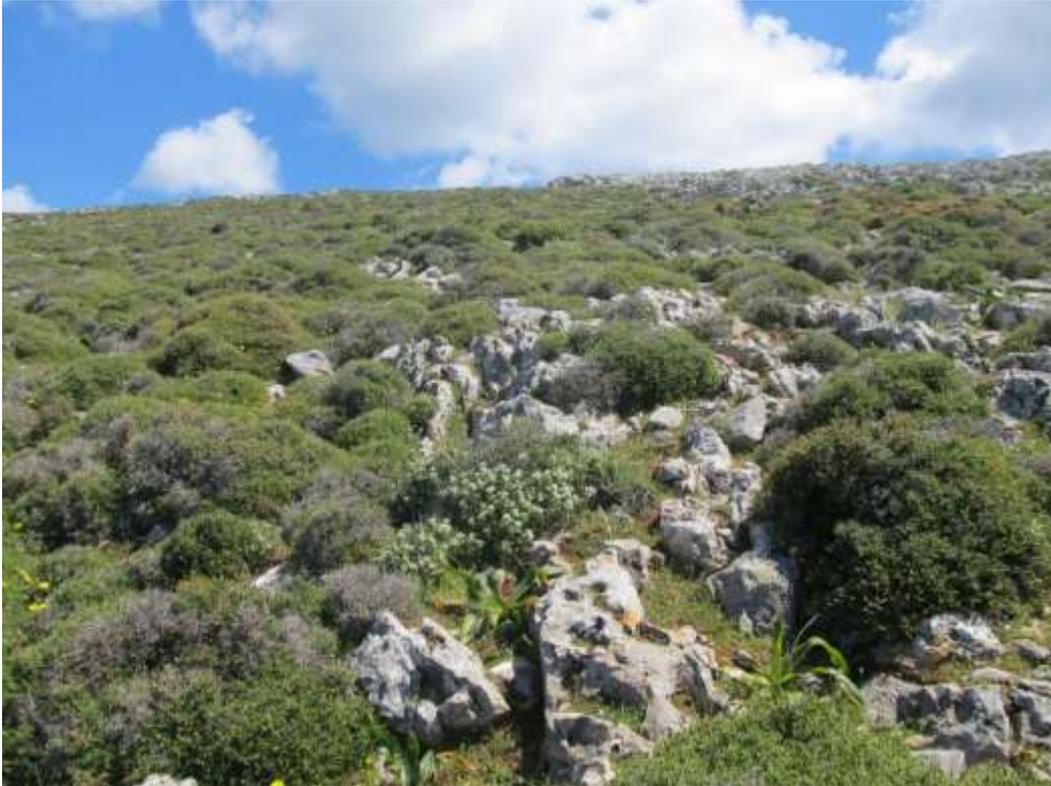
Photo1. The vegetation and soil conditions of the area of Aspro Vouno.

The bedrock is limestone throughout the area. The soil is calcareous, with a significant amount of surface rock (about 15%). The large vegetation coverage in combination with moderate slopes protects in a large extent the soil from erosion, despite intense grazing. The limestone rock is permeable to water and there is no aquifer close to the surface. The soil is clayey and poor in nutrients.

The area is overgrazed with degraded bushes and phrygana. The dominating species are the kermes oak (*Quercus coccifera*) and Mediterranean buckthorn (*Rhamnus lycioides*), the individuals of which have a height of 0.40m. In addition, the following shrub species are found in the site of Aspro Vouno: the broom (*Genista acanthoclada*), the pink rock-rose (*Cistus creticus*), the Jerusalem sage (*Phlomis fruticosa*), the *Prasium majus* and the Greek horehound (*Ballota acetabulosa*).

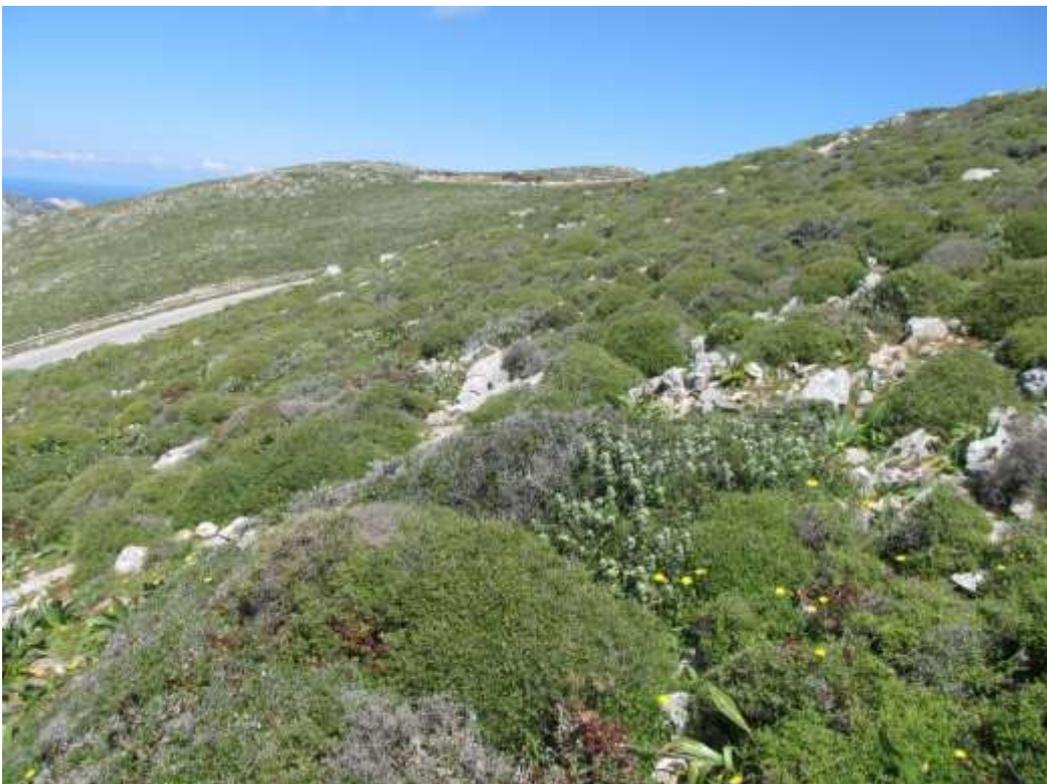
Photo2. The area from above to the east.

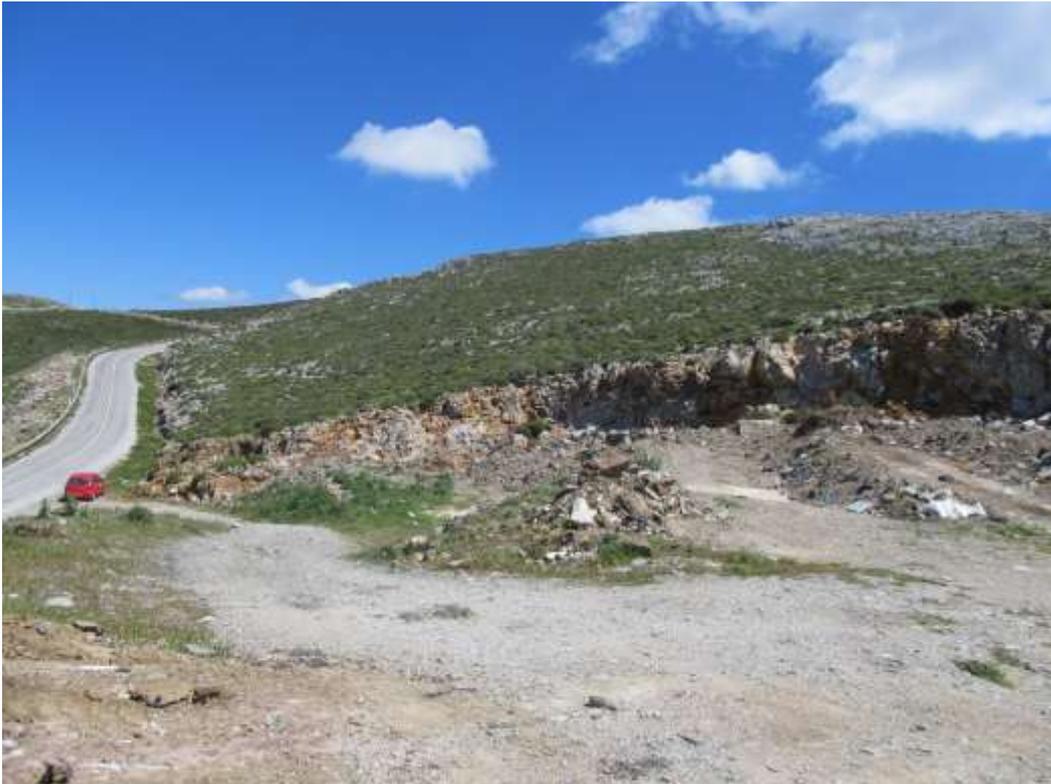
Photo3. The excavation of rubble deposition.from the west to the east.

The dump has a rocky front of maximum height 6m. This area includes excavations and construction deposits as well as old household devices. There are two squares (dumps) and downslope there is an elevated crest that gives a negative inclination, which leads north to free ('bulk') slope.

In the existing terrain there will be a small scale reshaping in the dump. The shaping will include leveling of deposits, removal of the household devices and scrap metal. There will be created two gentle slopes with gradient of 30% and a flat part. The display of the shaping is shown in the intervention map and in the relevant section.

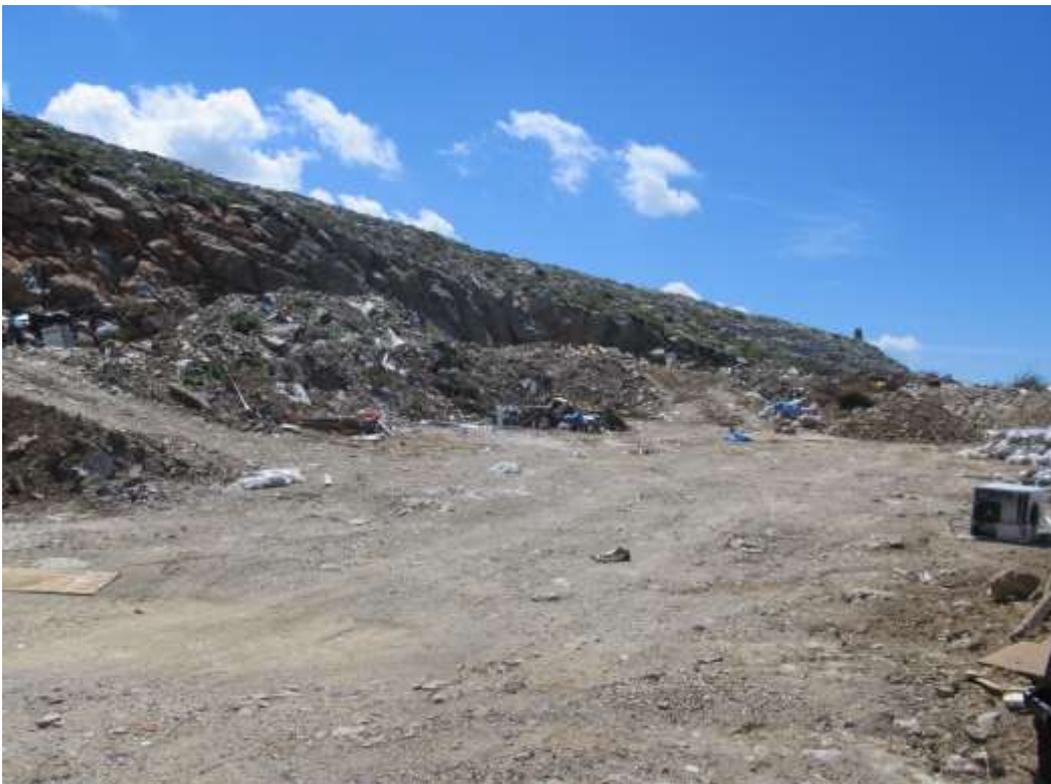
Photo4.The excavation of rubble deposition from the center to the west.

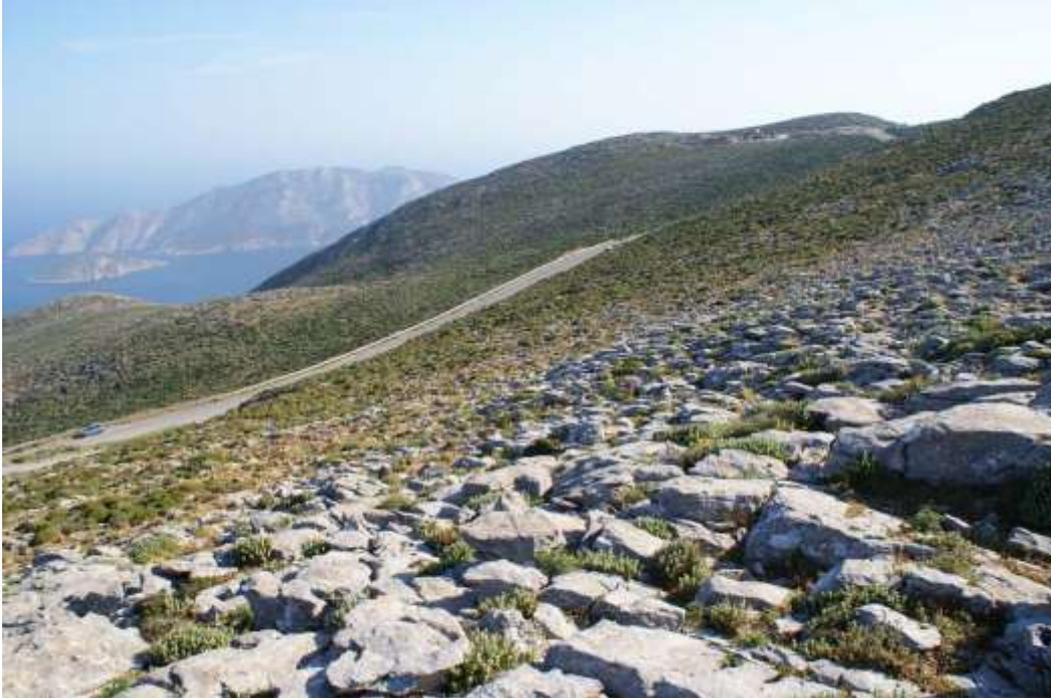
Photo5. The site is located downstream from the rocky ground of the picture. In the background view of the Nikouria area.

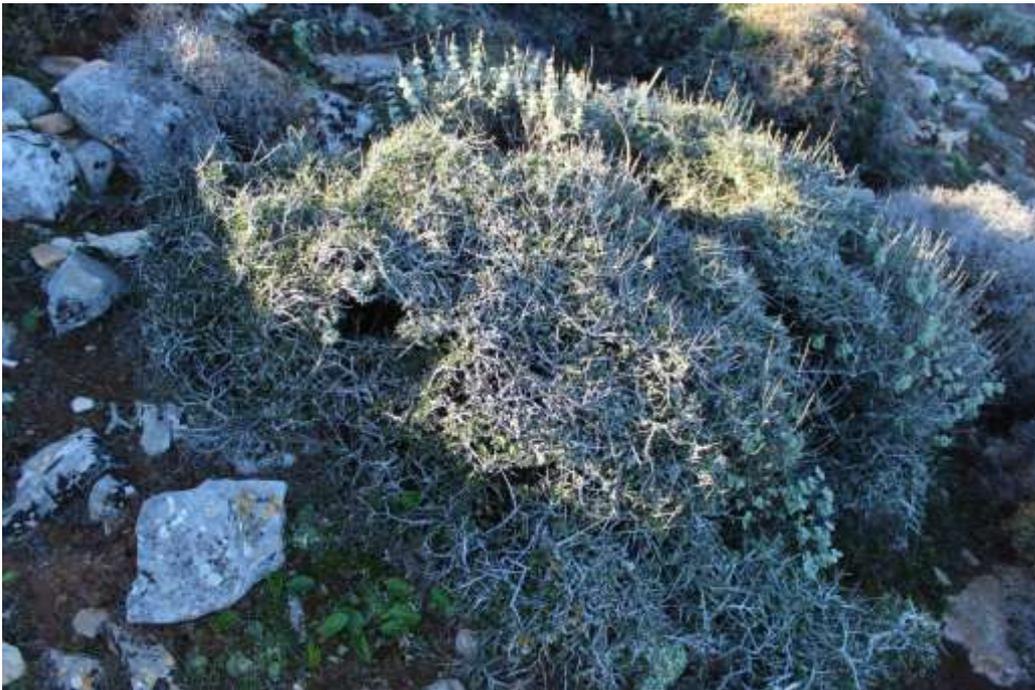
Photo6. The *Rhamnus lycioides* ssp. *oleoides* as results by the effect of overgrazing. The height does not exceed 20cm.
