MUNICIPALITY OF AMORGOS

Management
for ecosystem recovery
in Amorgos Island

Location: Kato Kampos

May 2014

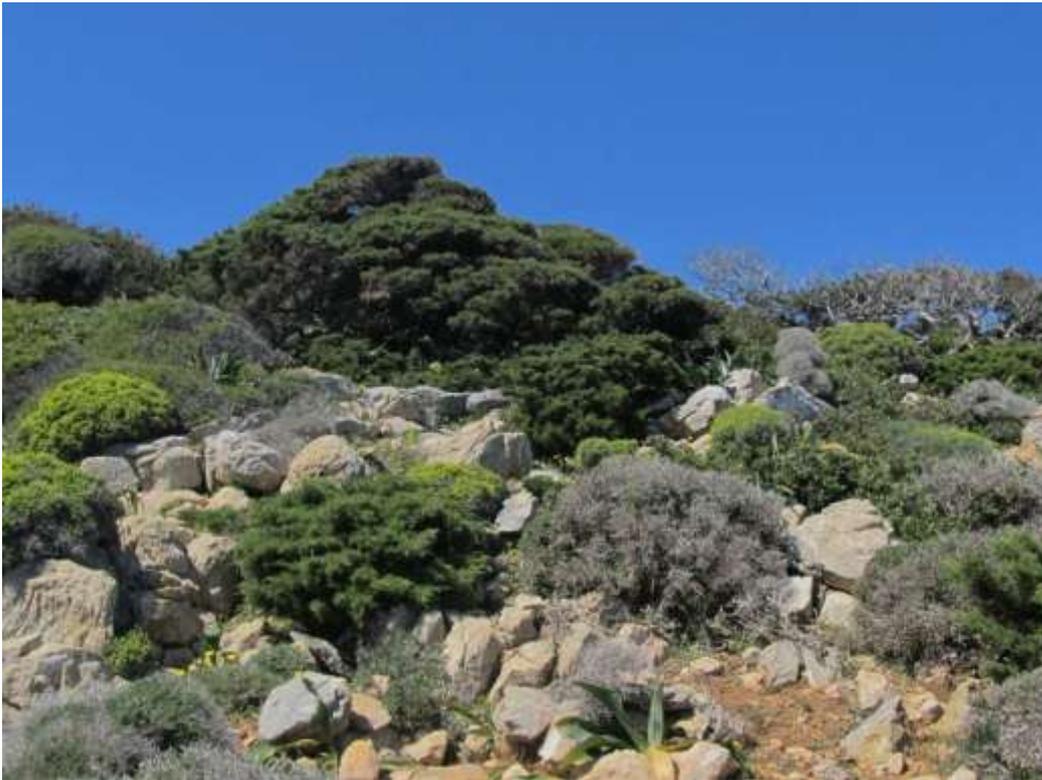
Photo1. The location Kato Kampos with the shrub species *Juniperus phoenicea* and *Pistacia lentiscus* along with phrygana.

It is a grazed area with Phoenician juniper (*Juniperus phoenicea*) and mastic tree (*Pistacia lentiscus*) and phrygana species as well. The bushy individuals reach are up to 2m tall and have good vegetation coverage of the area. Moreover, there are other shrubs, such as the mediterranean buckthorn (*Rhamnus lycioides*) and the Jerusalem sage (*Phlomis fruticosa*).

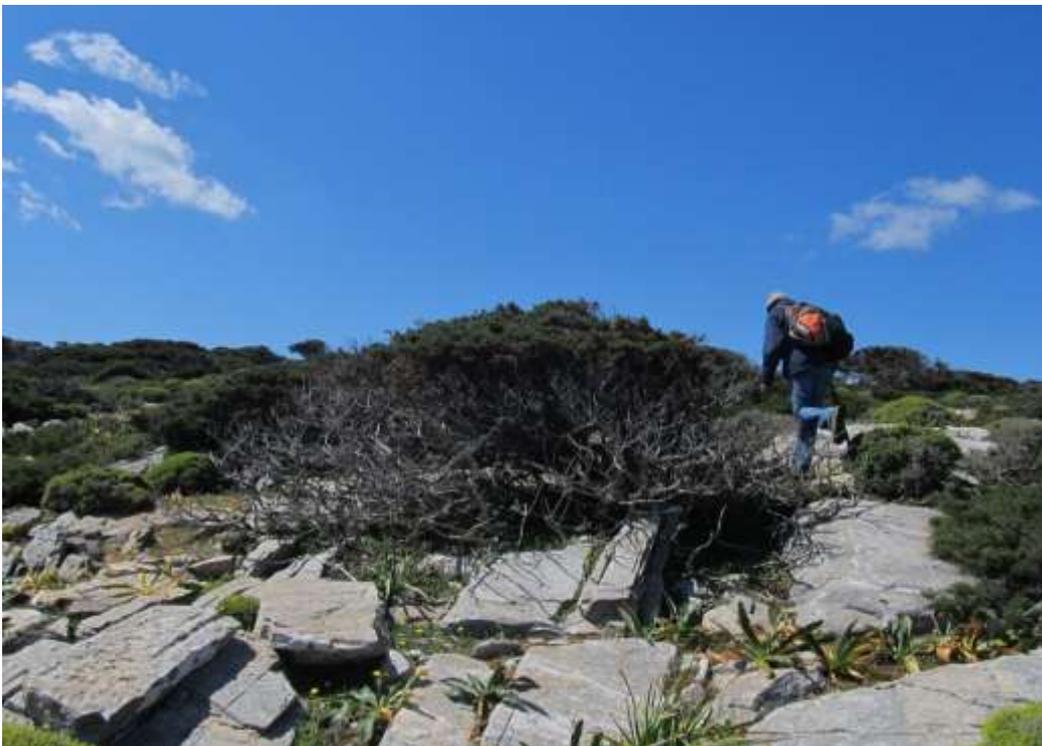
Photo2. Rocky ground in the eastern side of the peninsula.

The bedrock is limestone with presence of conglomerates in the eastern part. The soil is erodible in the east. In the ridge is rocky with amount of surface rock raised to 30%. The shrub vegetation coverage is significant (40-70%) and protects the soil from erosion, despite intense grazing that exists in this area. The area is fenced in the south side, the only land side. There is no aquifer near the surface, whereas the soil is poor in nutrients.

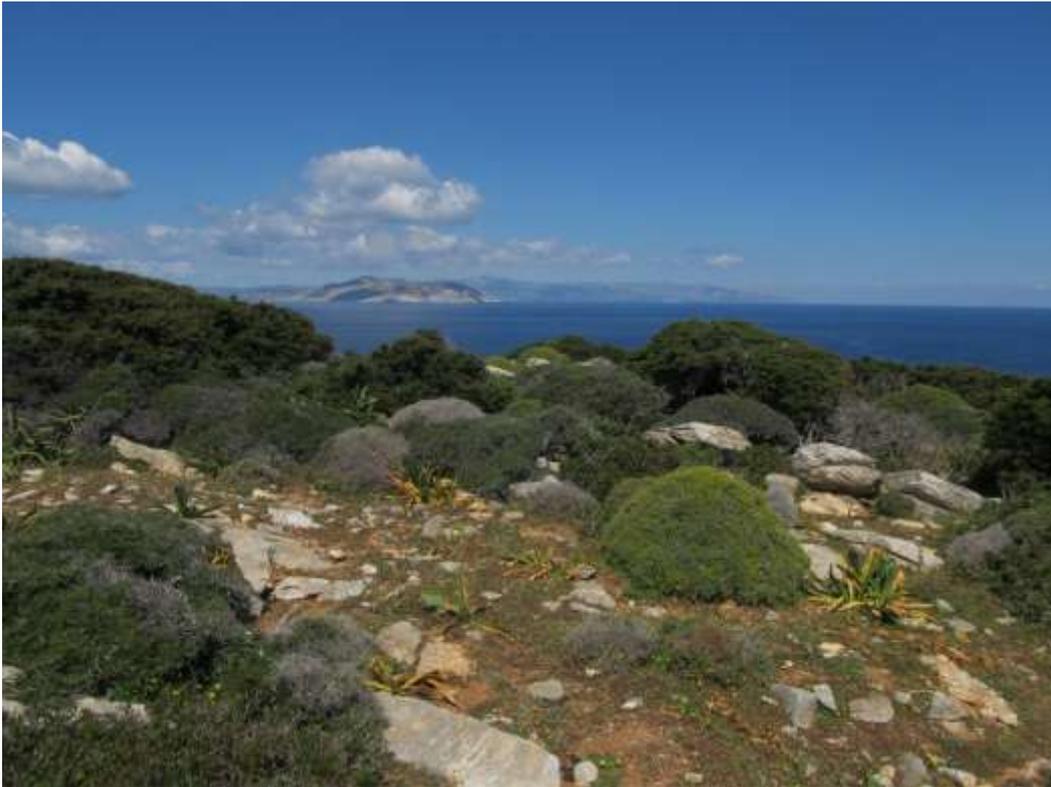
Photo3. In the ridge there are gentle slopes and denser shrub vegetation coverage. View to Keros and Naxos islands.

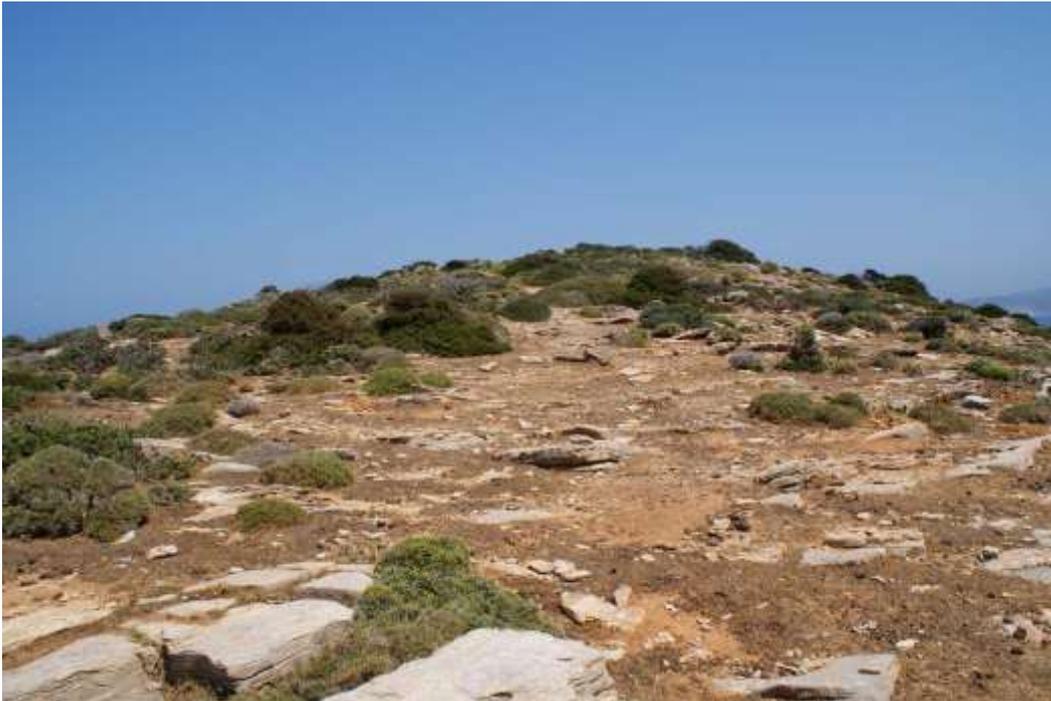
Photo5. Close to the southern end of the site, where it is projected to be the starting point of the terraces.

For this purpose, four long terraces will be built in the eastern side along the contours of 40, 48, 56 and 64m. These terraces will have a width of 0.40m and a height of 0.60m out of which 0.15m is the foundation.

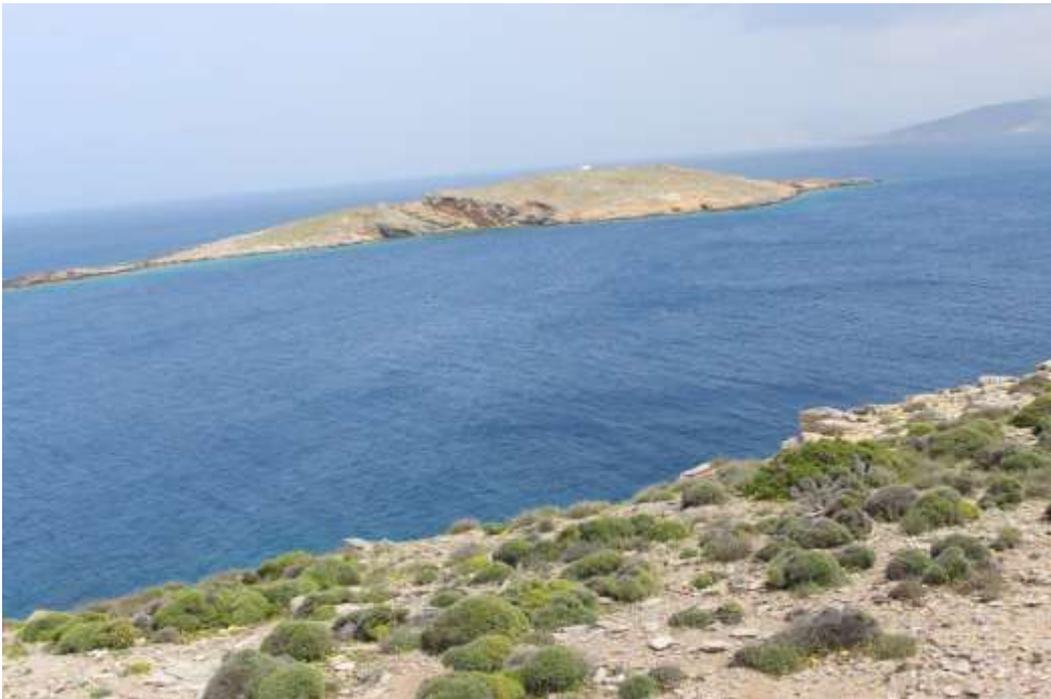
Photo6. At the northern end, strong wind creates adverse conditions for shrubs. View to the Petalidi islet.
